BACK TO BASICS

Restoring the original hip wood roof at James Madison's Montpelier required extensive framing repair before period-style cypress shingles could be added.

By Scott McBride

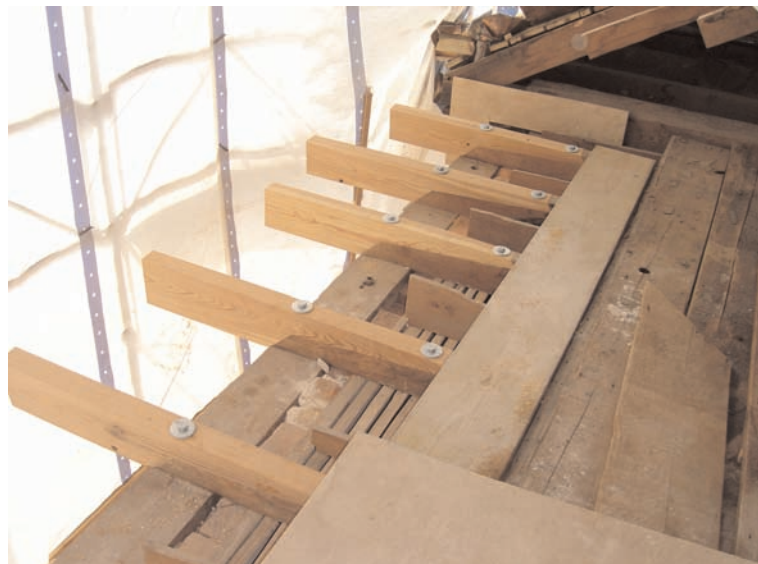
To restore Montpelier's cornice, the ceiling joists that had been cut off to interface with a 1901 addition were extended. After splicing on new material with a lag-bolted scarf joint, the joist extensions were trimmed to length. *Photo: Amy Wysocki*

A varied regimen of framing repairs was prescribed by structural engineer Dave Fischetti of DCF Engineering of Cary, NC. Where the cornice had been removed we used lag-bolted scarf joints to extend truncated ceiling joists. In the attic we replaced missing rafters in their entirety, but in some cases the DuPont carpenters had retained portions of the original common rafters to serve as shortened jack rafters. To restore these to their full length we spliced on new wood of the same species — mostly heart pine, but in some cases, oak or poplar.

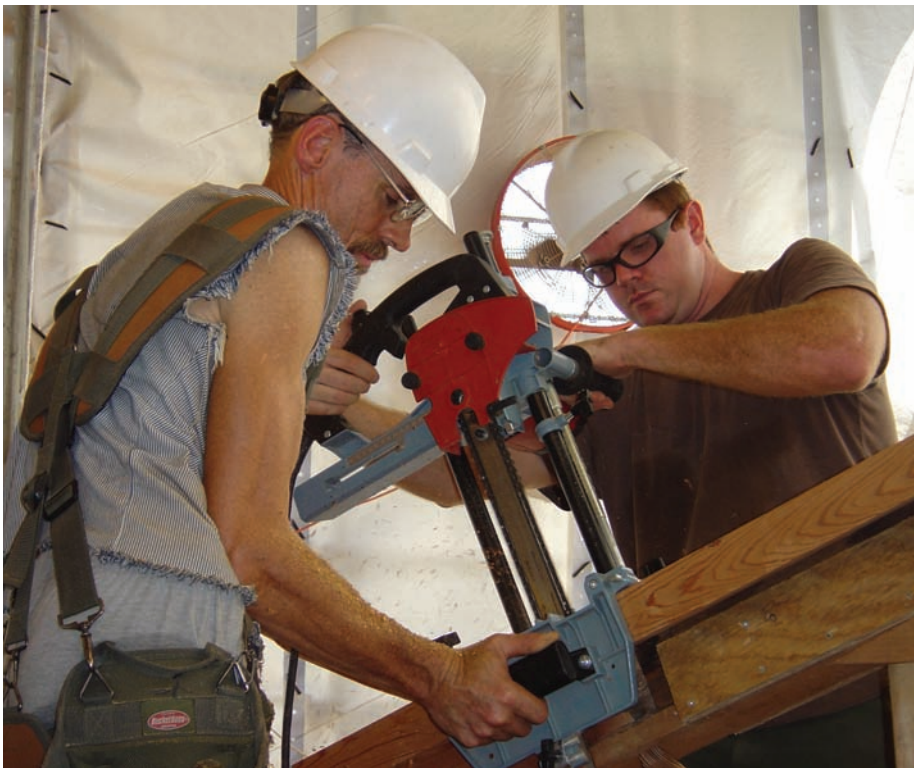
A spliced hip rafter was grooved with a chain mortiser to receive internal steel knife plates. *Photo: Amy Wysocki*

Instead of scarf joinery, we connected the old and new rafter sections with internal steel knife plates secured by self-drilling steel pins. The knife-plate system was originally developed in Germany as a fire-resistant alternative to surface-mounted timber framing hardware, but we focused on another advantage: the plates required only light end-trimming of the antique timbers, whereas scarf joints would have meant cutting away a substantial amount of original fabric. Also, slotting for the plates could be done in situ, whereas fashioning scarf joints in mid-air would have been onerous at

best. Our onsite testing confirmed the strength of the knife-plate system, and we used a Mafell chain-type mortising tool to plow the ¼-in.-wide slots.

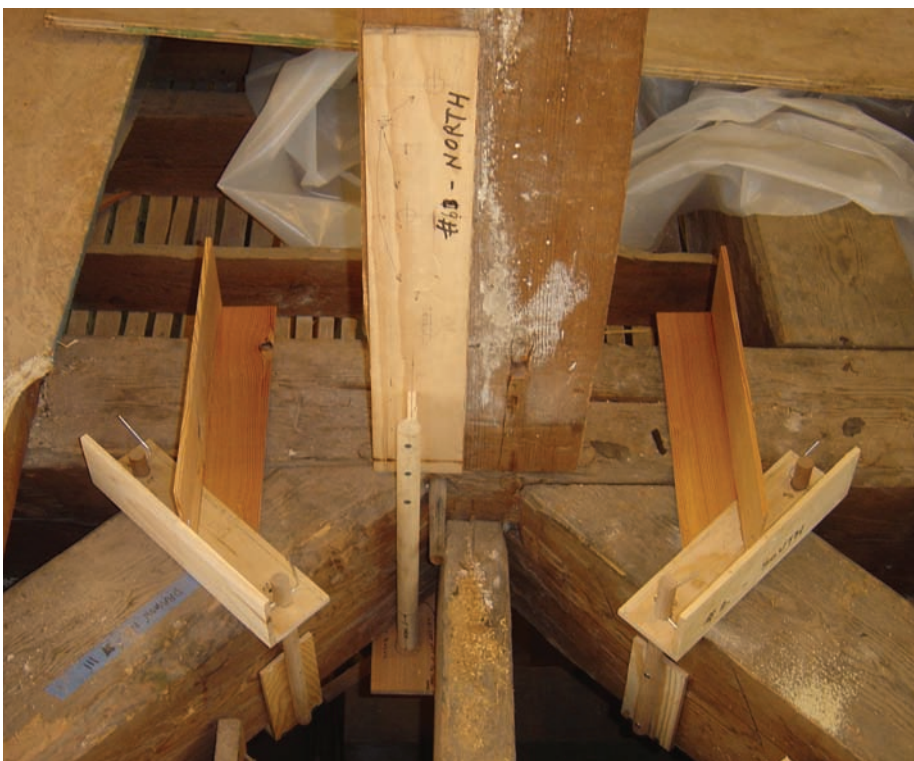
Two dragon beams, a joist and a kingpost all converge at the midpoint of the principal roof truss. The resulting mortises weakened the lower chord of the truss to the point of failure. After jacking up the truss, wooden patterns were made for specially designed steel hangers. *Photo: Amy Wysocki*

Montpelier's classic 18th-century roof frame consists of heavy king-post trusses interspersed with purlins and light secondary rafters. Another antique feature is Montpelier's dragon beams — heavy diagonal ceiling beams that run directly below each of the roof's four hips. This system is elegant but impractical because it concentrates extreme loads at a few key points. A serious problem occurred where both dragon beams and kingposts had been tenoned into lower chords at mid-span. This traffic jam of converging timbers resulted in a cluster of mortises that had weakened the lower chords to the point of failure. A later hand-forged iron staple had only made matters worse. To remedy the situation, Fischetti designed custom steel hangers, which we had fabricated by a machinist. We provided the machinist with a custom-fitted wooden pattern for each location to cope with the vagaries of hand-hewn framing members.

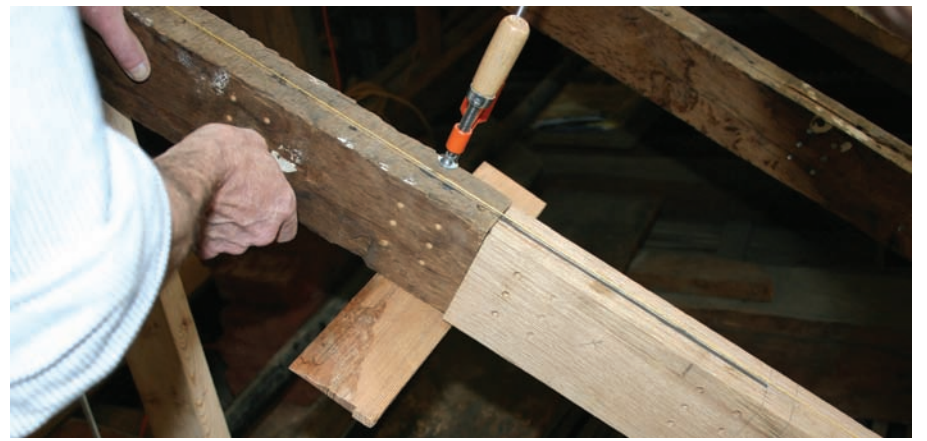
This 18th-century rafter (left) was severed in 1901 to accommodate roof alterations. A new extension (right) was attached by means of an internal steel knife plate that bridges the joint. The plate drops in from the top and is secured by four sets of self-drilling steel pins. *Photo: Maggie Wilson*

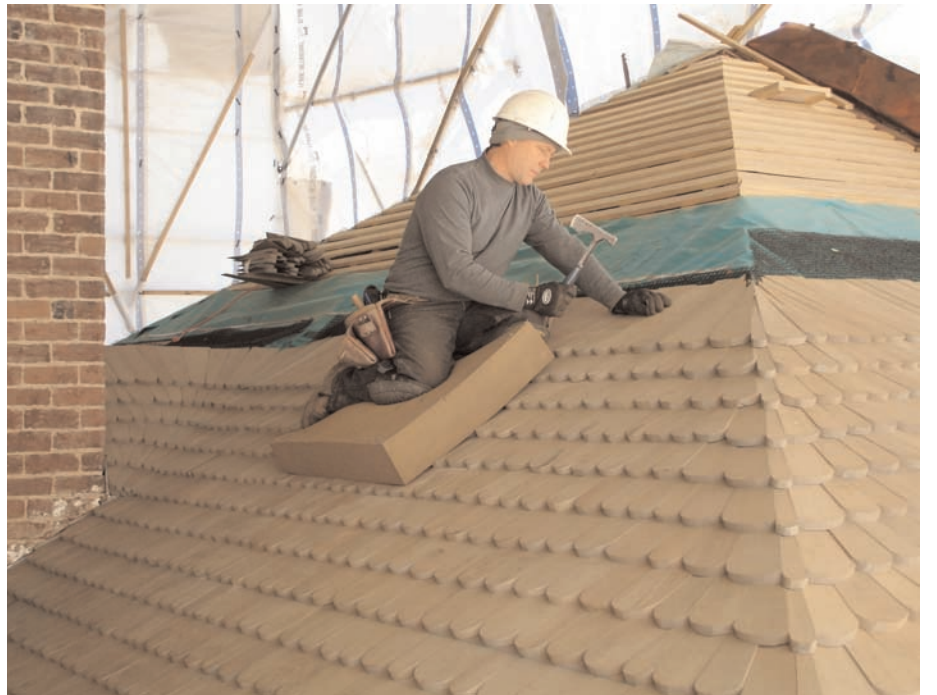
Old-growth cypress shingles were laid over new spaced battens to restore Montpelier's roof surface. The green membrane is Roof Shield, and the black mesh just above the shingles is Cedar Breather. A swept valley is visible behind the chimney at left, and a fanned hip appears on the right. The carpenter's foam rubber cushion protects shingles during installation.

In addition to the tear-drop feature, the hips at Montpelier are "fanned" – a typical southern shingle detail of the period. Fanned hips feature progressively canted side-joints, which create a pagoda-like effect. Roof valleys of the period were fanned like the hips, but in reverse; the width of a valley shingle narrows toward the butt rather than the feather end. The technique is called "sweeping" the valley.

To physically rehearse the details at Montpelier, Post shingled a 12-ft. mockup that included a hip and a valley. To ventilate the shingles, we removed the 1850s solid sheathing and replaced most of it with spaced battens, but a 40-in.-wide strip of solid sheathing at the eaves was lined with EPDM rubber as a defense against ice dams. Rubber was also installed beneath valleys as further backup protection against leakage. The entire roof was underlaid with Roof Shield, a highly vapor-permeable, self-sealing membrane that lasts longer than felt. Cedar Breather was used under the shingles throughout as another way to promote drying.

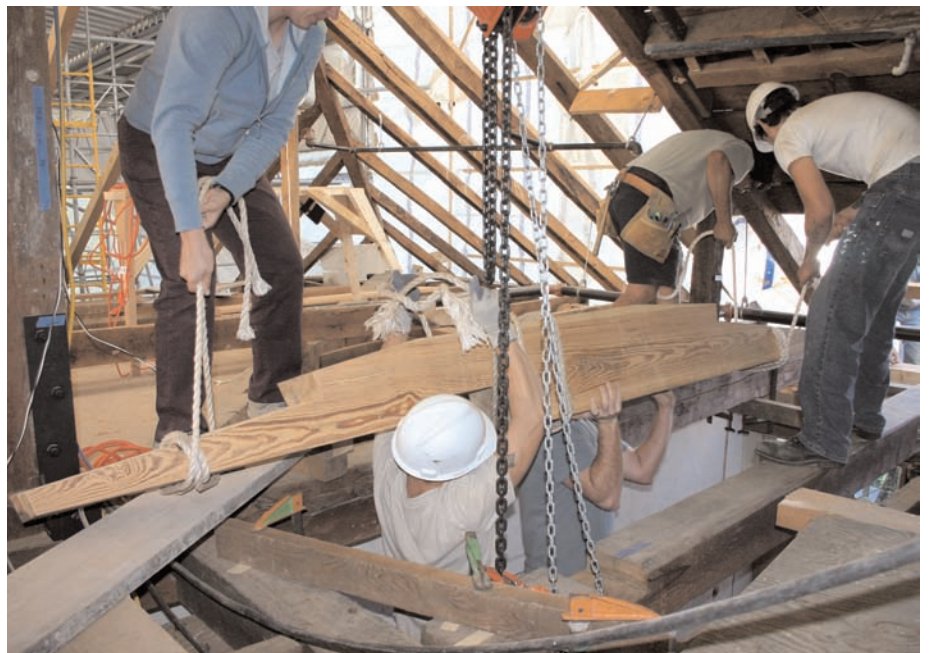
One of the beams that ties Montpelier's portico to the house had rotted clean through, so a 12-ft. section in the middle had to be replaced. Bolted scarf joints united replacement material with the original fabric. Reclaimed heart-pine timbers were salvaged from a textile mill in South Carolina. *Photo: Maggie Wilson*

Longstanding leaks caused our biggest headaches. Water had seeped into wall plates and truss chords, turning them to mush. One of the principal tie beams connecting Montpelier's Tuscan portico to the house had rotted clean through. Repairs required extensive shoring before the ailing timbers could be operated on. After trimming back the decayed areas to sound wood we incorporated new timber by means of keyed scarf joints reinforced with through-bolts. In some cases the surgery had to be performed from within the portico entablature — a narrow chamber barely wide enough for a worker to squeeze into.
