Singular Details

Rebuilding the cornice of the Octagon house

by Scott McBride

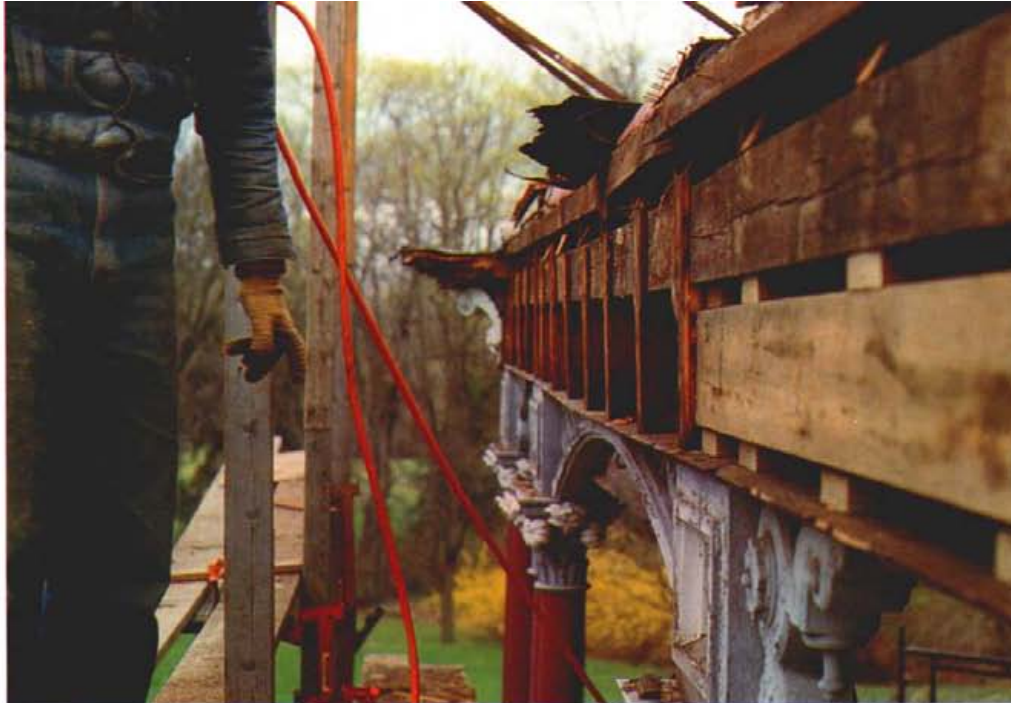
To make the lintels look beefier than they are, the original builders dropped the lintel soffit nearly a foot below the lintel and framed in the space between the lintel and the soffit with 2x6 cripple studs. The author replaced the studs beneath each damaged section of the lintel with a 6x8 beam (at right in photo), adding blocks to transfer the load.

Our worst fear was that we'd find the lintels and the rafter ends bearing upon them to be thoroughly rotten. That would require a complete rebuild of the elaborate coffered ceiling of the porch. Fortunately, damage to these elements turned out to be minimal and—thanks to the design of the lintel—relatively easy to fix. In order to give the finished lintel an appearance of greater depth, the original builders had dropped the lintel soffit nearly a foot below the 6x8 lintel itself and framed in the resulting dead space with 2x6 cripple studs. That allowed us to yank out the cripple studs beneath damaged sections and to replace them with 6x8 beams, positioning the beams to bear on two adjacent porch columns (photo above right).

Also, instead of splicing the lintels over the intermediate columns, the original builders had used one continuous lintel for each side of the house, each a whopping 32 ft. long. That made it possible for us to prop up each damaged lintel section with temporary posts which were offset from the porch columns and out of our way while we slipped the new 6x8s into place. Once the beams were home, we added blocking to transfer loads from the old lintels to the new beams.

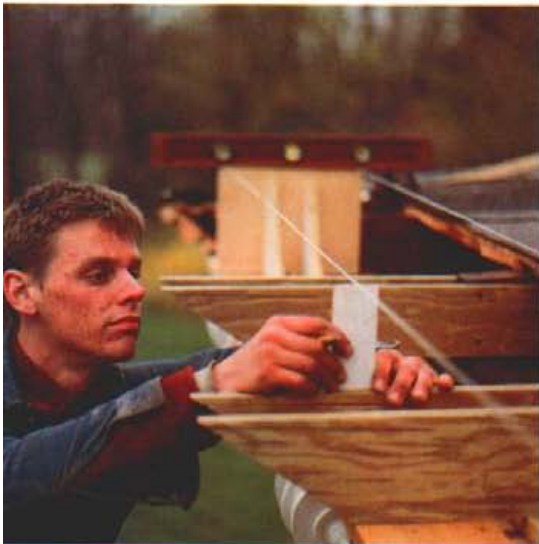
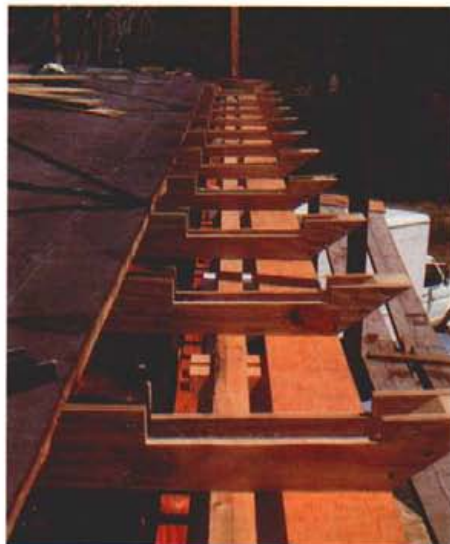
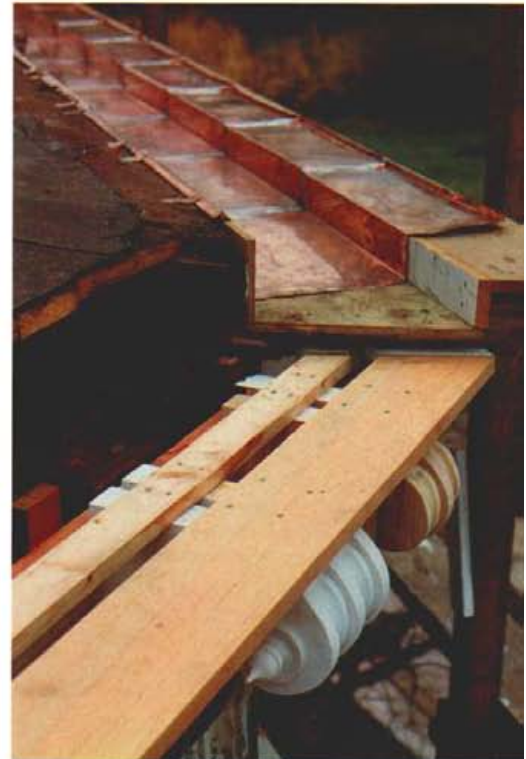
To lay out the lookouts for the gutters, workers stretched a pair of strings between temporary supports on opposite ends of the cornice so that the strings paralleled the desired slope of the gutter. The depths of the cutouts were then established by touching a measuring stick against the string and marking the lookouts at the bottom of the stick (photo below left). Cut lines for the sides were squared down from chalklines snapped across the tops of the lookouts. Once the lookouts were removed, cut out with a bandsaw and reinstalled, they formed a perfectly straight inclined trough to house the gutter (photo below center). The brackets support a split soffit (photo below right), which serves as a level foundation for the built-in gutter. The new copper lining for the gutter was cut into small square sheets and soldered at the seams, typical of the 19th century.

Next, we nailed down two pieces of the cornice soffit to the tops of the brackets. Duplicating the original design, we used clear pine for the exposed outboard-half of the split soffit and common spruce for the hidden inboard half (photo next page, bottom right). A split soffit was less likely to cup than a solid soffit and it saved on material.

support at each end of the cornice so that the strings were on an incline parallel to the desired incline of the gutter (photo facing page, bottom left). The incline was calculated so that the lookout at the high end of the gutter would be cut only slightly and the lookout at the low end would be cut to within an inch of its bottom.

Next, I made a measuring stick equal in length to the desired distance from the strings to the bottom of the cutouts. The stick was beveled at one end and left square at the other. By just touching the strings with the beveled top of the stick and marking the lookouts across the bottom of the stick, we were quickly able to establish the elevation of the bottom of each cutout. The sides of the cutouts were simply squared down from parallel chalklines snapped across the top edges of the lookouts. Once the lookouts were removed, cut out with a bandsaw and reinstalled, they formed a perfectly straight inclined trough ready for plywood (middle photo, facing page). The cutouts for the splayed lookouts at the corners of the house were extrapolated from the common lookouts with a straightedge after the commons were installed.
